Manhole Inspection Summary

Manhole # S67Q__010MH

Insp Date: **5/15/08 1:30 PM**

Location Address: **1500 Imla St.**

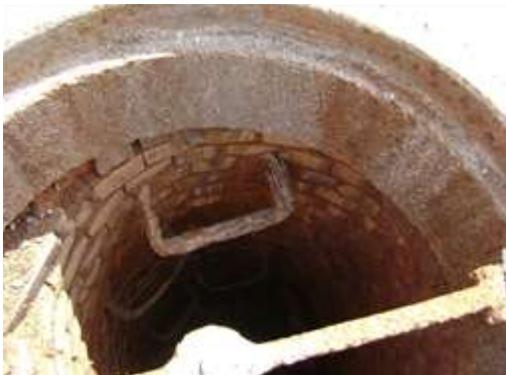
Defect 3

Condition: ☐ Sound ☒ **Cracked** ☐ Root Intrusion ☒ **Loose Brick** ☒ **Deteriorated**

Deterioration

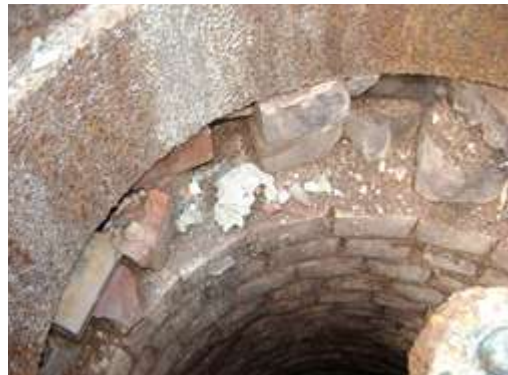
Defect 1

Infiltration: ☐ None ☒ **Joint** ☐ Cracks ☒ **Mortar** ☐ Roots ☐ Wall

Loose bricks and missing mortar under frame

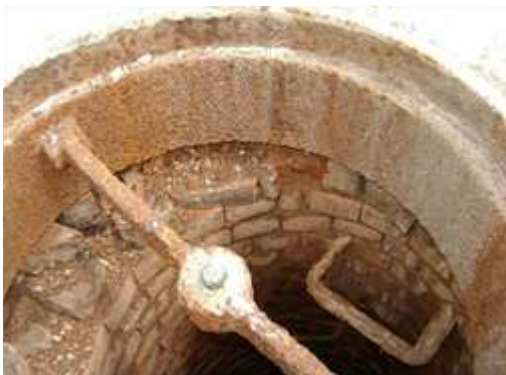
Defect 2

Frame Offset: **3** (in.) Condition: ☐ Sound ☒ **Cracked** ☐ Leaks

frame offset

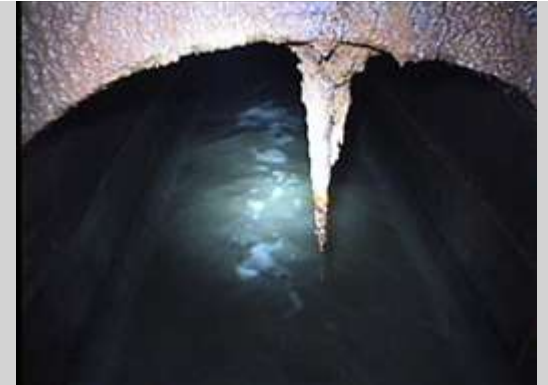
12 O'Clock Outflow

54 in. Circular Gravity Sewer
Pipe Out @ 12 O'Clock

Pipe Height: **55.2** (in.) Rod and Bar (Angled)
Pipe Material: **Concrete** ☐ Pipe Lined
Invert Depth: **20.75** (ft.) Flow Characteristics: **Fast**
Deposits: ☒ None ☐ Mud ☐ Sludge ☐ Debris ☐ Grease
Silt Depth: (in.) Deposits Extent:
Infiltration: **None** Pipe Seal Cond: **Sound**

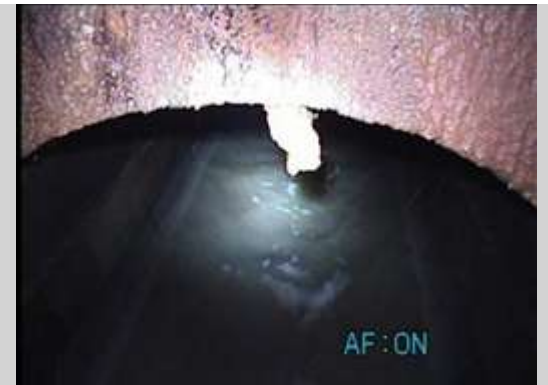
6 O'Clock Inflow

54 in. Circular Gravity Sewer
Pipe In @ 6 O'Clock

Pipe Height: **54** (in.) Rod and Bar (Angled)
Pipe Material: **Concrete** ☐ Pipe Lined
Invert Depth: **20.58** (ft.) Flow Characteristics: **Fast**
Deposits: ☒ None ☐ Mud ☐ Sludge ☐ Debris ☐ Grease
Silt Depth: (in.) Deposits Extent:
Infiltration: **None** Pipe Seal Cond: **Sound**

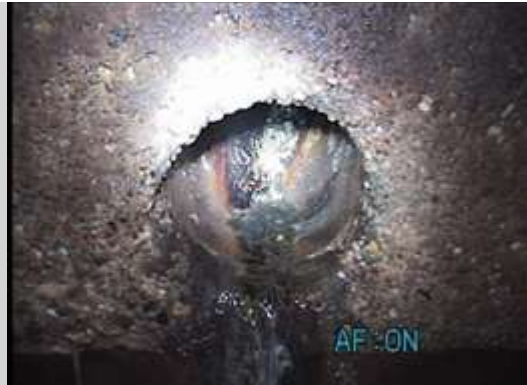
9 O'Clock Inflow

6 in. Circular Gravity Sewer

Pipe In @ 9 O'Clock

Pipe Height: **6** (in.) Rod and Bar (Angled)

Pipe Material: **Clay** ☐ Pipe Lined

Invert Depth: **16.50** (ft.) Flow Characteristics: **Slow**

Infiltration: **None**

Pipe Seal Cond: **Sound**
